What replaces the replacement windows?

This library, which houses rare books and manuscripts for an Ivy League university, is a marble neoclassical building built around 1900. Around 25 years ago the University replaced the old wood windows with new insulated glass windows, custom made from teak. But the new windows experienced warping, shrinkage and chronic leakage, which prompted the University to look for remedial options.

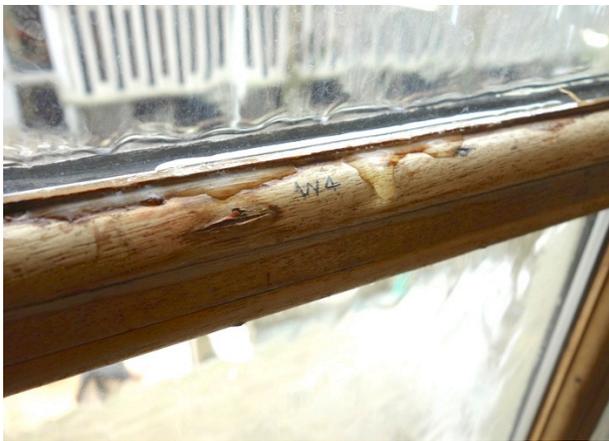
During this water test, water easily bypasses the glass perimeter sealant and enters the building. Options for replacing this sealant proved to be very expensive.

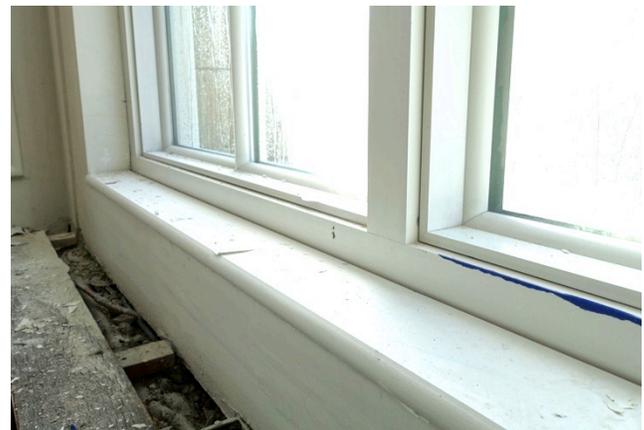
Leakage was causing damage to the plaster as well as rotting out the window sills.
