The intractable problem of leakage through stone arches

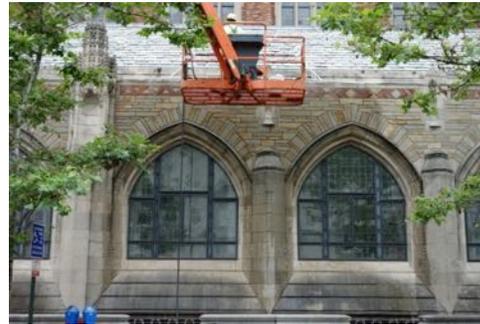
A Collegiate Gothic building at a well-known university experienced chronic leakage through the limestone arches over a series of seminar rooms. We water tested and found several problems, including a severely rusted steel beam that caused a crack through the masonry, and the absence of flashing over the arches. But even after correcting these issues, and pointing the mortar joints, there was residual leakage directly through the radial joints of the arches.

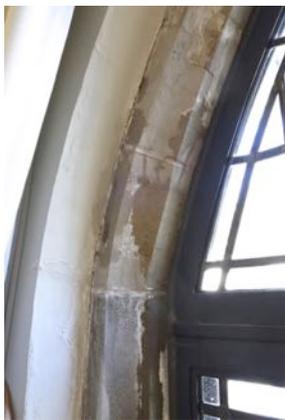
Water testing before and after the repair helps verify that the solution is working.

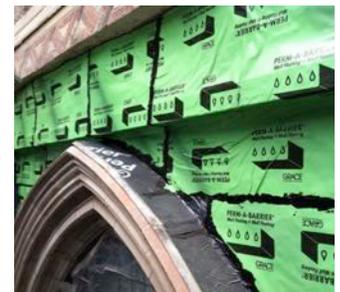
First we addressed severe rusting in a beam that was cracking the masonry

Granite facing was reinstalled over a new membrane and copper flashings.

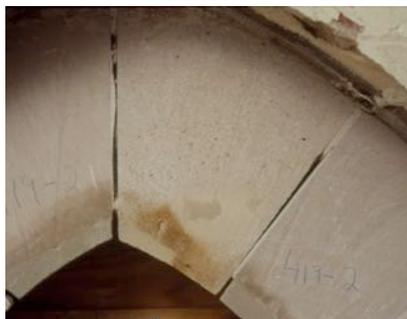
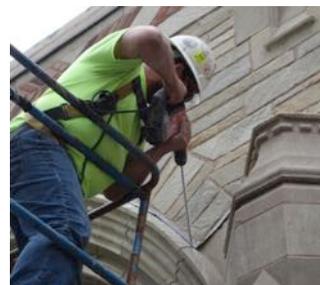
Example of an arch where the face of was cut away, to reveal joints where the mortar had slumped down and left a gap.

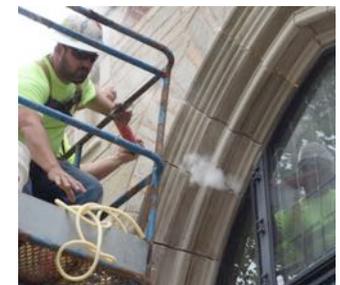
Drilling through the mortar joint to inject flowable grout

The solution was not merely to point the mortar joints, but to drill deep and inject the voids with flowable grout to the full depth of the joint. Although it's not possible to fill every part of the mortar joints reliably, water testing showed that this reduced the leakage to negligible levels compared with the original conditions.

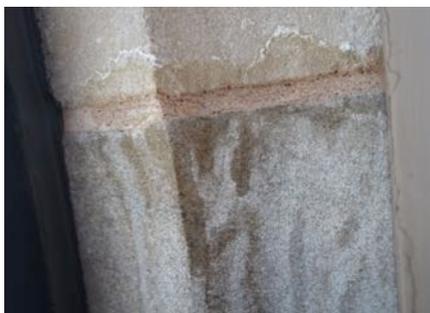
Pumping air into the joint makes a puff that shows a void extends through the arch.

Water seeping straight through mortar joints, even after installing the flashings and water barriers.
