Historic church sanctuary restored better than new.

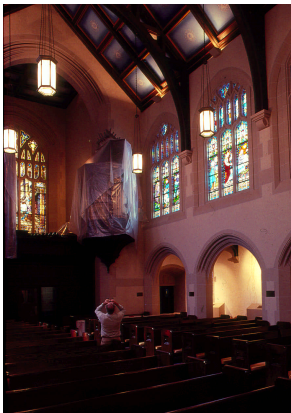
When we first arrived, we saw the organ pipes covered with plastic to prevent water damage.

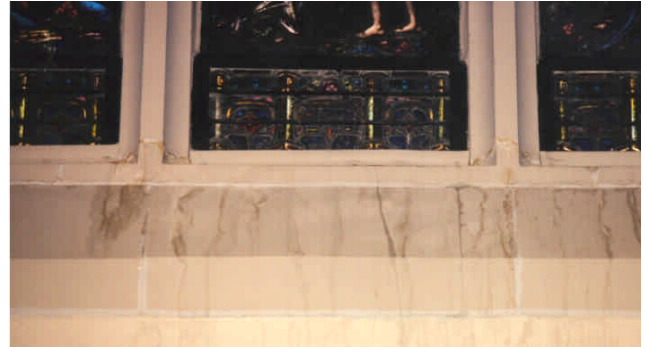
Slow leakage through parapets had permitted termites to eat the wood lath behind the plaster

Before the installation of new roof flashings, water was flooding through the stained glass windows and tracery.

All the copings were re-built with copper flashings to prevent continued leakage and deterioration of the masonry
