Brick buildings sometimes need to be pointed, but don't expect it to cure deeper problems.

This building, now a luxurious condominium, was built in the 1920's using durable masonry construction. But it was plagued for decades by a patchwork of unexplained leaks, some worse than others. A \$1 million program of repairs, including pointing, was completed with very little effect. The condominium management looked for better advice and decided to call Leavitt Associates.

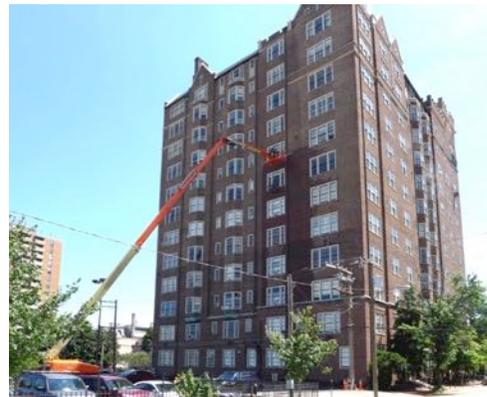
Water tests were conducted from a boom lift.

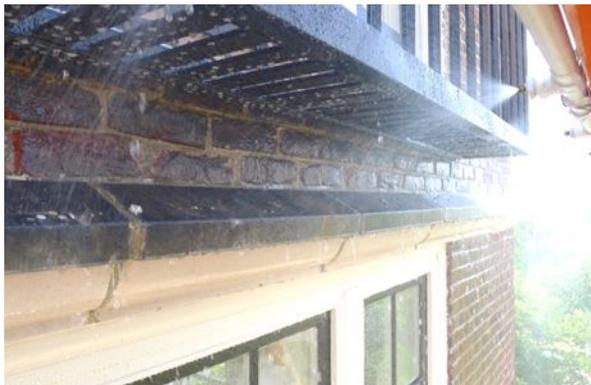
Leakage showed up in a variety of locations, for example, above window heads, and below window sills in projecting bay windows.

Water tests showed that water was entering at rusting shelf angles and lintels, which had cracked the brick. Pointing only concealed the problems from view. It did not keep water out.

We conducted a series of water tests and concluded it was unrealistic to promise a simple, economical fix to stop all leakage. We decided to concentrate efforts on a few of the most severe leakage areas, because durable and reliable repairs are very expensive. They include flashings over some window sills, and rebuilding masonry, including new flashings, where rusting steel has caused cracks through the wall. Brick buildings do need to be pointed sometimes, but don't expect it to cure deeper problems in a 12" or 16" wall.

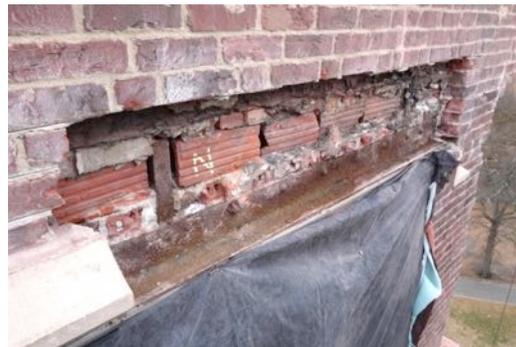
Some leakage came from shelf angles. The steel had rusted severely, and the original asphaltic flashings were destroyed.
