When the answer is not found in any roofing manual

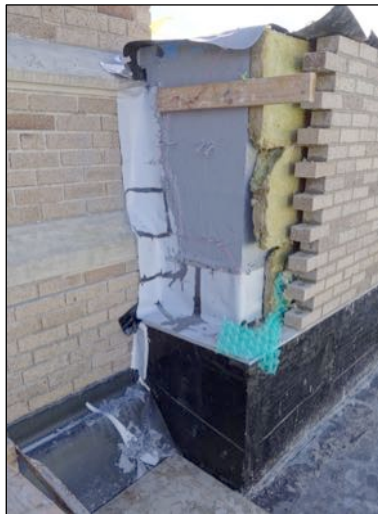
This coping intersection was never properly detailed, and roofed over with white tape and contact cement.

The contractor had to stop work and temporarily patch this area where an expansion joint passes from asphaltic waterproofing, through a brick veneer wall and coping, to a TPO roof on the upper deck.

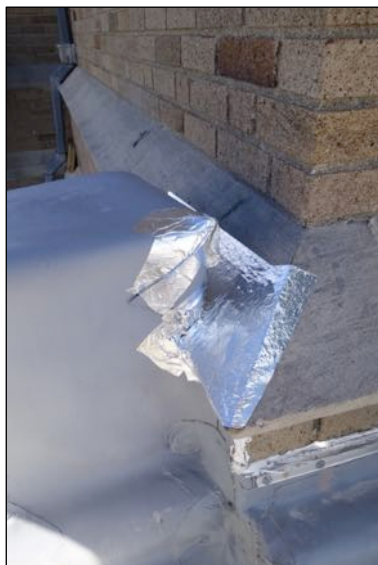
On the opposite side of the photo above, the TPO roof needs to join to a limestone belt course, while allowing the expansion joint to pass over the top of the coping, and join to the expansion joint on the roof side of the coping.
