## Pioneering cathodic protection system stops damage from rust.

Cathodic protection has a century-long track record but has seldom been used for historic buildings – until now.

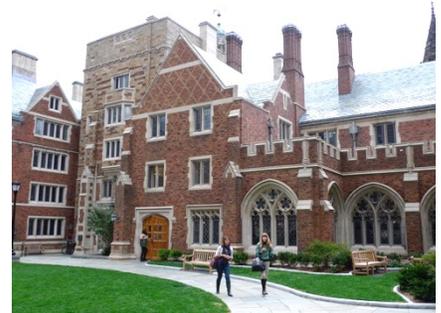
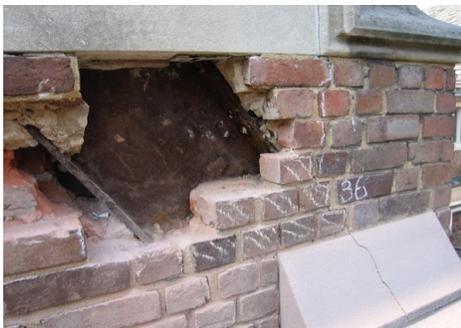
When the time came to renovate this residential college, we noticed that mysterious cracks appeared all over the masonry. It turned out they were caused by accumulated rust scale on structural steel embedded in the masonry.

Cracks through the masonry originated at the flanges of steel beams

The solution was to uncover and remediate all steel that had rusted to the point where it cracked the masonry, and install a cathodic protection system on the upper two floors of the building. Cathodic protection has a century-long track record of experience in tunnels, bridges and water treatment facilities but has seldom been used in historic buildings, until now.

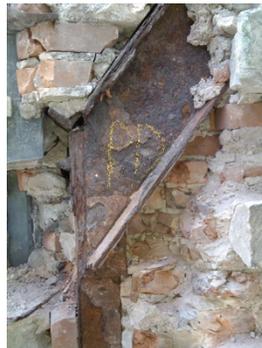
Severely rusted steel was uncovered, painted with a cementitious alkaline coating, and then cathodically protected from future corrosion.

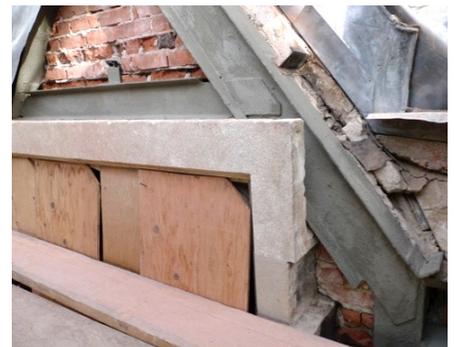
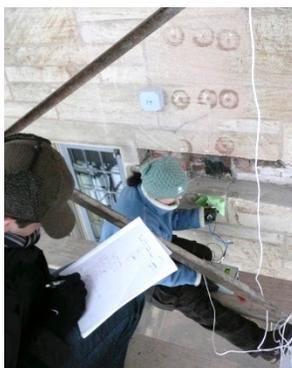
Electrochemical measurements were used to estimate how fast the rust was spreading. They showed little or no risk of corrosion on lower floors.

Cathodic protection for the upper floors would be enough to stop all meaningful rust far into the future.

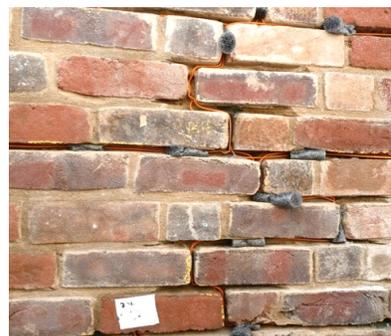
Titanium and ceramic anodes, drilled into the wall at pre-set locations, were connected to their power source by titanium wires embedded in mortar joints.
