Design Review Solves Problems in Advance.

Design intent of world-renowned architects implemented without sacrificing durability

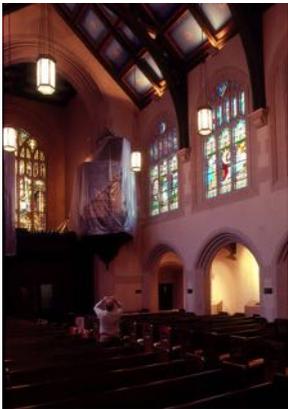
When we first arrived, we saw the organ pipes covered with plastic to prevent water damage.

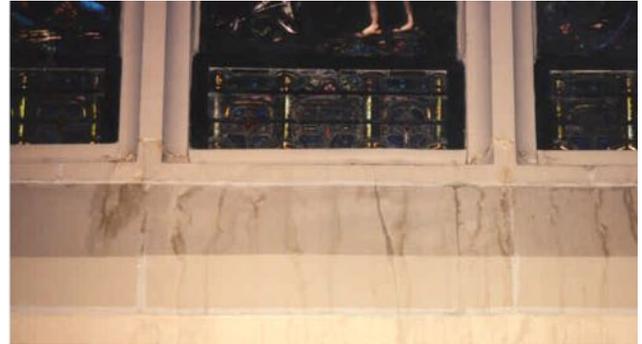
Before the installation of new roof flashings, water was flooding through the stained glass windows and tracery.

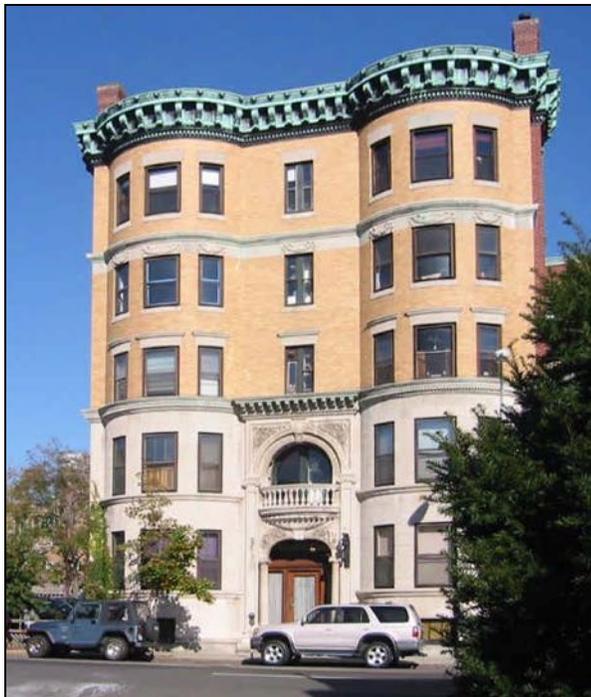
Exterior masonry on the Brentford Condominium was restored over a period of several years, with the most critical areas addressed first. Areas that were re-pointed blend visually with the areas that were not re-pointed, avoiding the need for a total repointing.

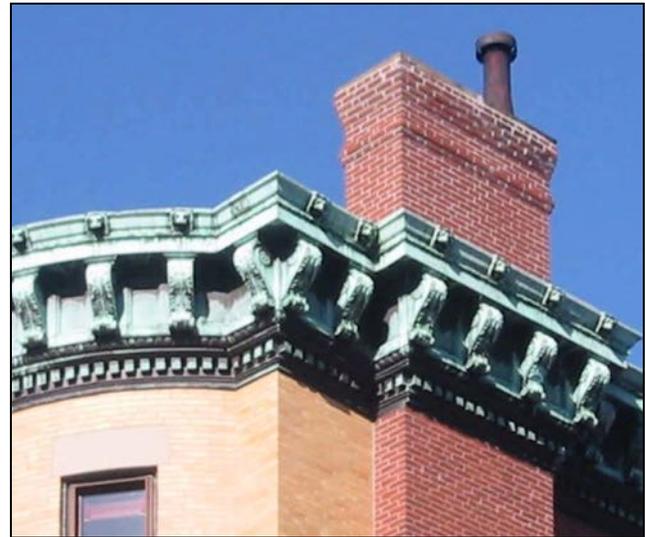
We examined the copper cornices and were able to reattach pieces that had come loose, avoiding an expensive replacement program. Chimneys were completely rebuilt.

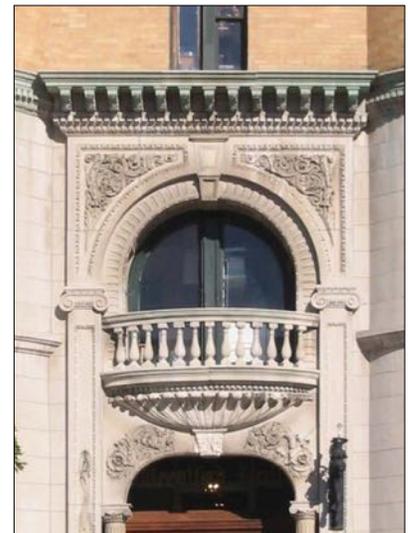
The limestone balconies were partially reconstructed, including replacement of missing balusters.

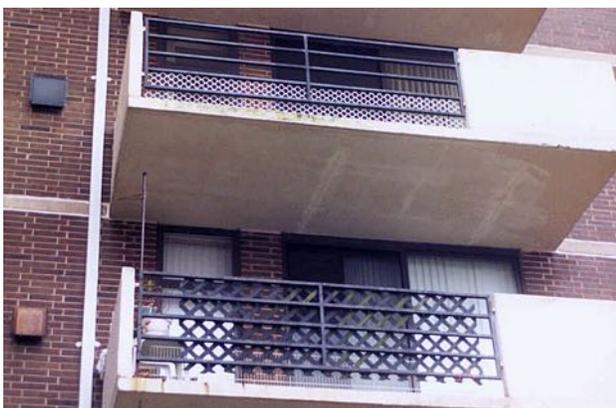
The original construction had concrete floor slabs exposed at the edges, a source of chronic leakage

Management had been "child-proofing" individual balcony guardrails as best it could. These rusted guardrails were replaced with new galvanized steel as part of the re-cladding.

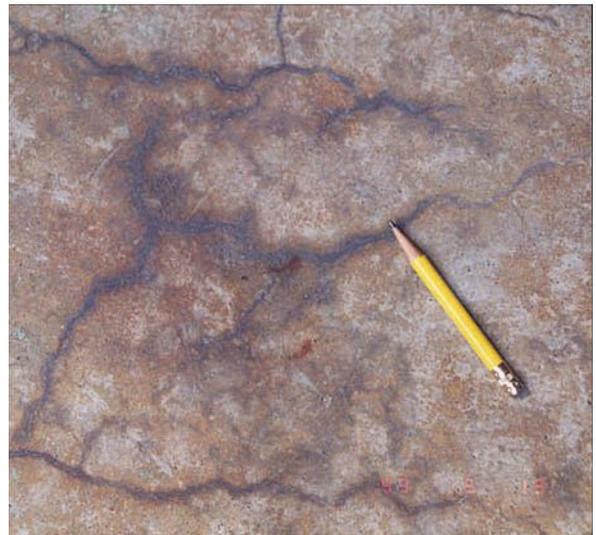
Steel reinforcement in the balconies was starting to rust, causing cracks in the concrete. We used protective chemical inhibitors and coatings to slow the deterioration

New EIFS cladding has stopped all leakage and makes the building much more attractive to tenants in this community near the beach front.
